Manhole Inspection Summary

Manhole # S41W1_019MH

Insp Date: **12/12/07 8:06 AM**

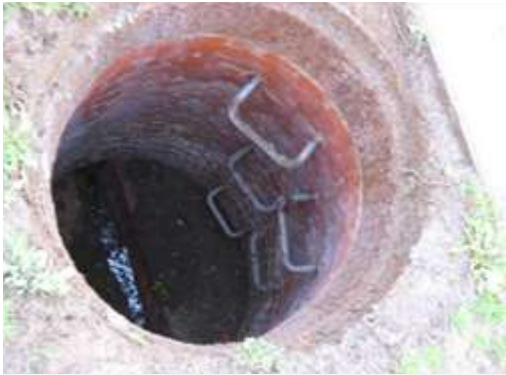
Steps Count: **5** Missing: **0** ☐ Corroded

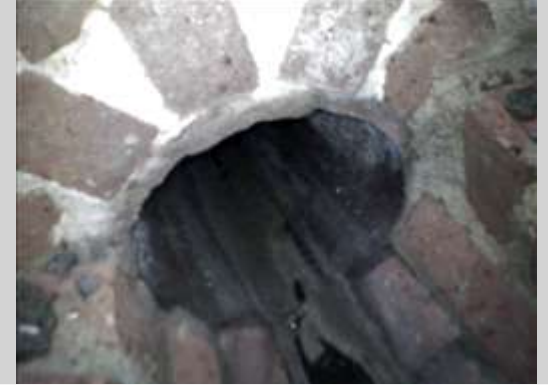
12 O'Clock Outflow

8 in. Circular Gravity Sewer
Pipe Out @ 12 O'Clock

Pipe Height: **10.8** (in.) Rod and Bar (Angled)
Pipe Material: **Clay** ☐ Pipe Lined
Invert Depth: **9.58** (ft.) Flow Characteristics: **Slow**
Deposits: ☒ None ☐ Mud ☐ Grassy ☐ Debris ☐ Grease
Silt Depth: (in.) Deposits Extent:
Infiltration: **None** Pipe Seal Cond: **Sound**

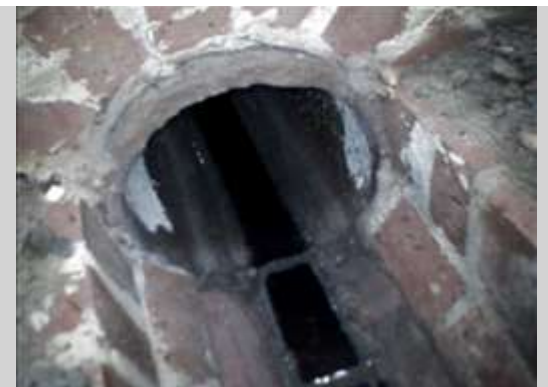
6 O'Clock Inflow

8 in. Circular Gravity Sewer
Pipe In @ 6 O'Clock

Pipe Height: **10.8** (in.) Rod and Bar (Angled)
Pipe Material: **Clay** ☐ Pipe Lined
Invert Depth: **9.32** (ft.) Flow Characteristics: **Slow**
Deposits: ☒ None ☐ Mud ☐ Grassy ☐ Debris ☐ Grease
Silt Depth: (in.) Deposits Extent:
Infiltration: **None** Pipe Seal Cond: **Sound**

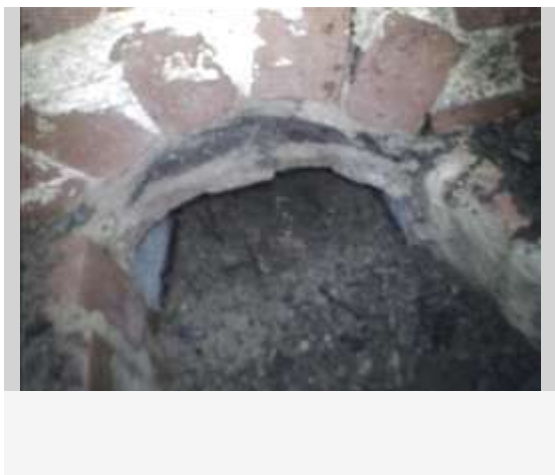
9 O'Clock Inflow

6 in. Circular Service Sewer
Pipe In @ 9 O'Clock

Pipe Height: **9.6** (in.) Rod and Bar (Angled)
Pipe Material: **Clay** ☐ Pipe Lined
Invert Depth: **9.38** (ft.) Flow Characteristics: **None**
Deposits: ☐ None ☒ **Mud** ☒ **Sludge** ☐ Debris ☐ Grease
Silt Depth: **3** (in.) Deposits Extent: **Medium**
Infiltration: **None** Pipe Seal Cond: **Cracked**
